REPORT NATF-EN-1132

BAK-14 RETRACTABLE HOOK-CABLE SUPPORT SYSTEM
COLD-WEATHER TESTS AT GALENA, ALASKA

Waldemar Wastallo
Recovery Division, Engineering Department
Naval Air Test Facility
Naval Air Station
Lakehurst, New Jersey 08733

27 AUGUST 1974

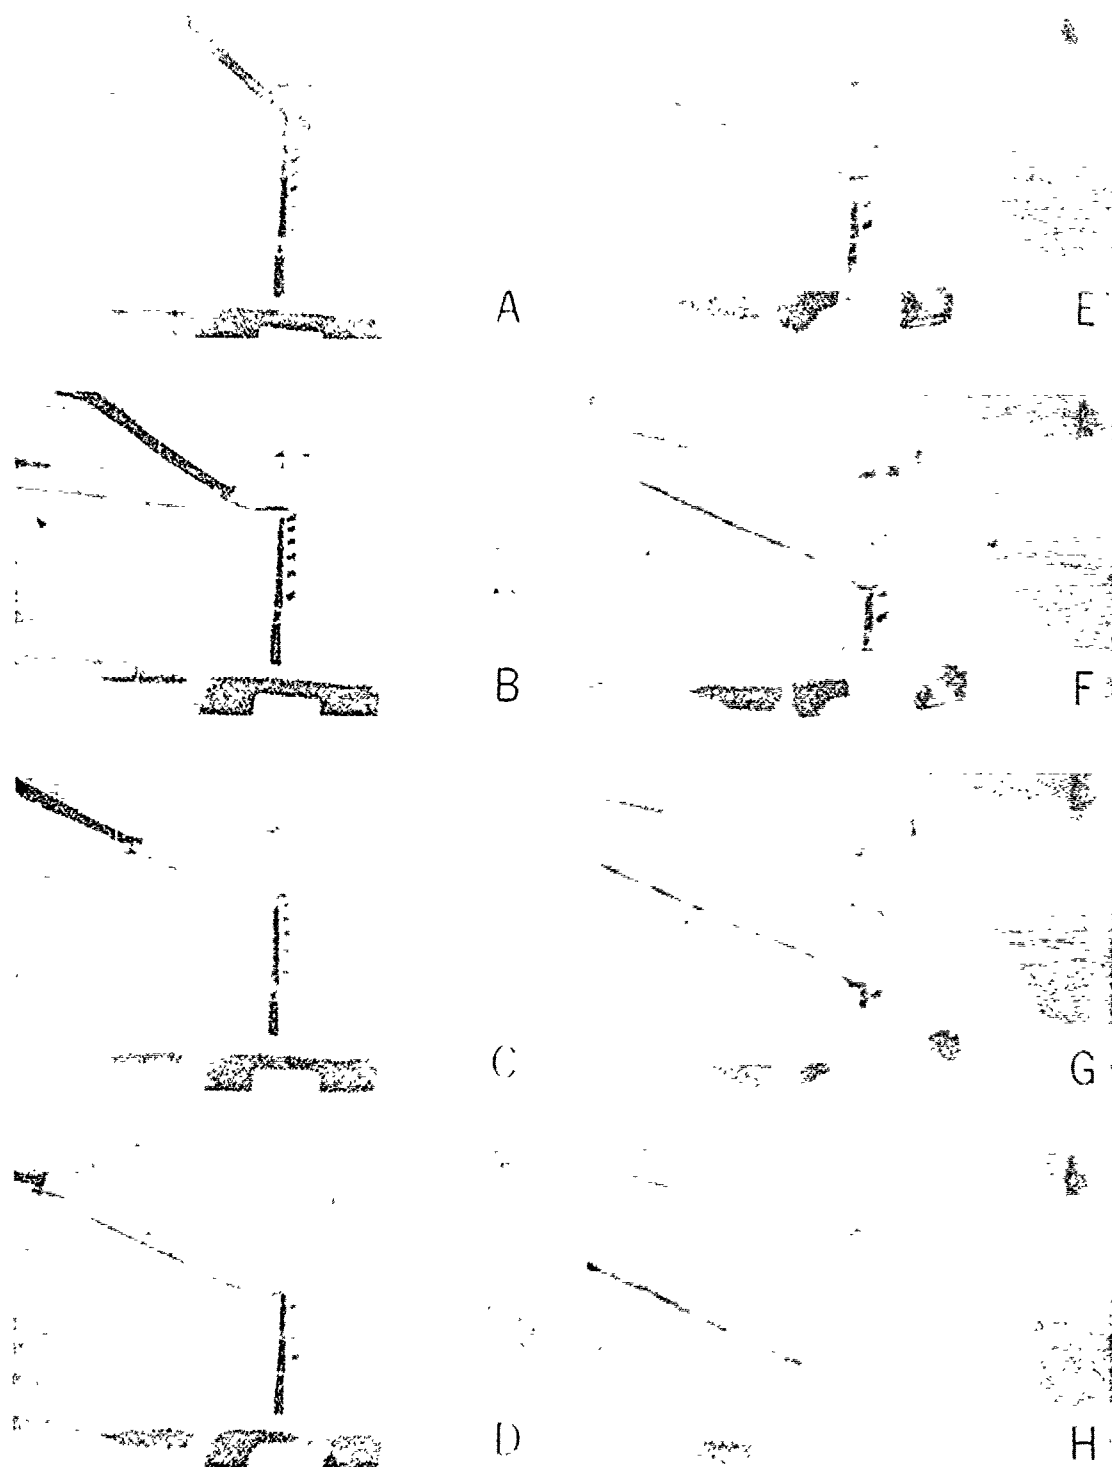
FIGURE 12 - HIGH-SPEED MOTION-PICTURE FILM SEQUENCE OF EVENT 13: F-4E
AIRCRAFT 60-KNOT INDICATED AIRSPEED ENGAGEMENT OF BAK-12
ARRESTING SYSTEM EQUIPPED WITH BAK-14 HOOK-CABLE SUPPORT SYSTEM

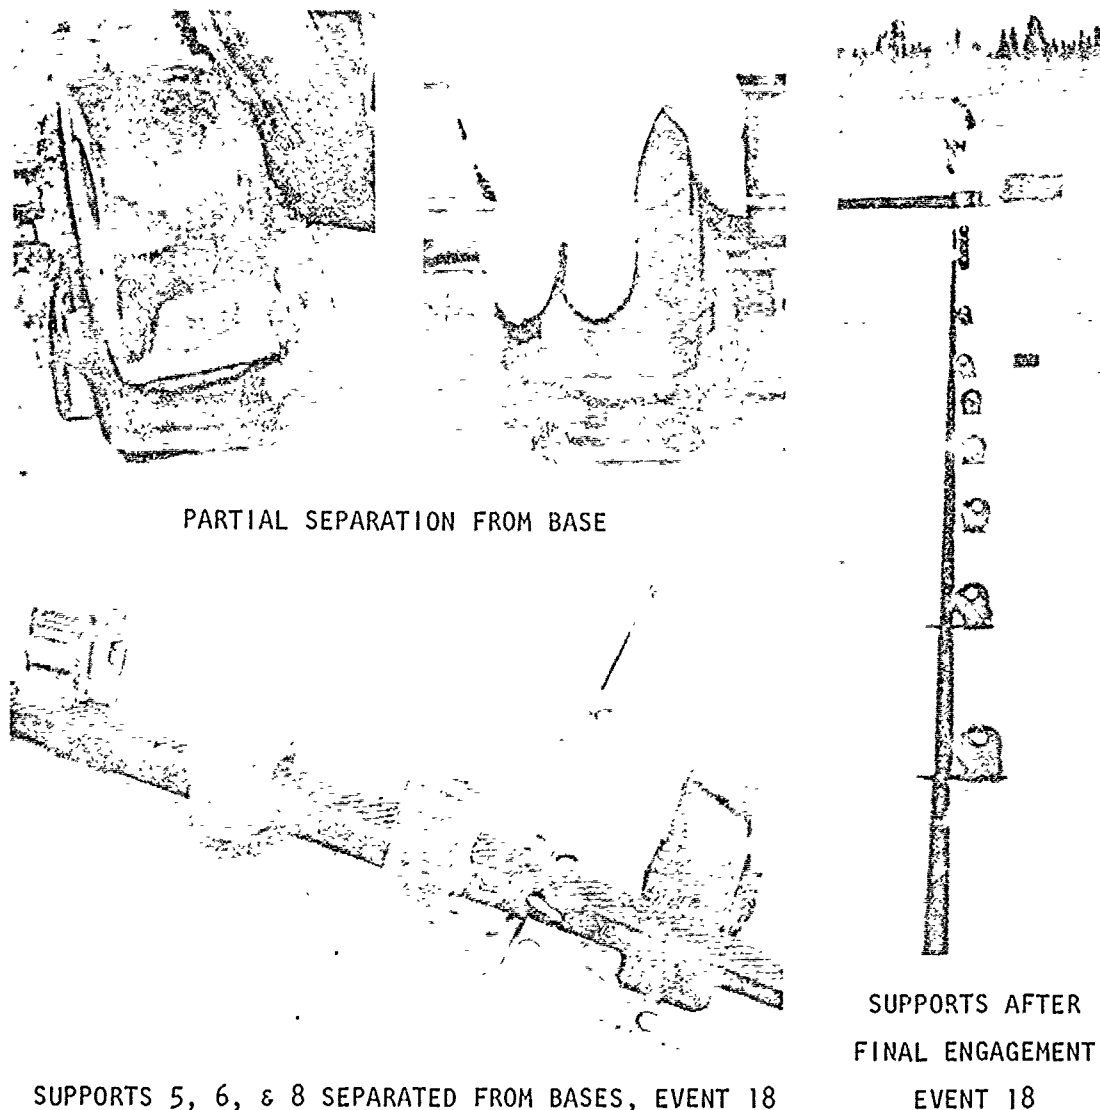
(b) The more serious area of failure occurred within the metal frame base of the support as shown in Figure 13, where the rubber partially separated from the base. After the last arrestment, supports 5, 6, and 8 were separated from their bases, and supports 5 and 6 remained attached to the hook cable during the arrestment and retrieve (see Figure 13). All the remaining supports were split and partially separated from their bases (see Figure 13). The failure mode indicates that both the nylon-restraint and the pivot-shaft through holes decrease the area of the load carrying cross section and seriously weaken the support within the metal frame base.

FIGURE 13 - VIEWS OF FAILED CABLE SUPPORTS

2. The neoprene rubber support blocks were unsatisfactory because of their hardened condition at the low ambient temperatures. The loads imposed during arrestments caused partial to complete separation of the 14 blocks from their bases. (Section IV, Paragraph B1b)

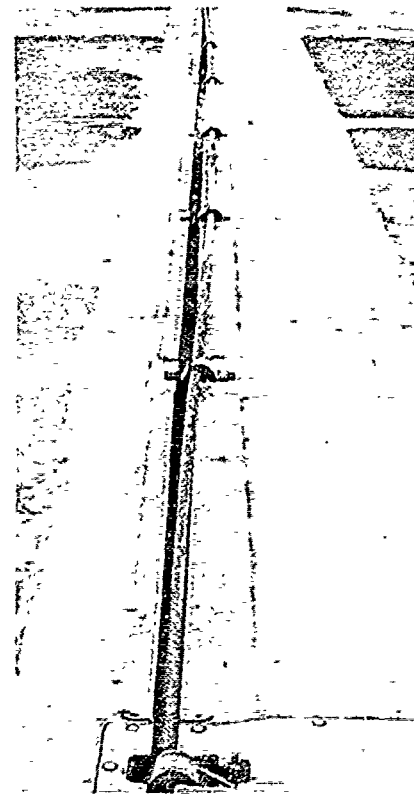
2. CYCLE TESTS: After the aircraft tests were completed, the BAK-14 was returned to operating condition for the 100 cycle tests as follows: the 14 damaged supports were replaced; support box 8 pusher block was realigned; the bent latch pivot shaft of support box 9 was straightened; the pivot shafts of support boxes 8 and 9 were reinstalled with their brackets fastened to the support arm with 10-32 x 1/2-inch-long screws; and 5 support-block latches were adjusted. After the repairs were completed, system cycle operation was satisfactory; however, when the initial 50-cycle test was started, the latch of support block 4 would not retract and prevented retraction of the entire cable (retract hangup) as shown in Figure 15. Adjustment of the latch corrected the problem.

FIGURE 15 - HOOK-CABLE RETRACT HANGUP
CAUSED BY JAMMED SUPPORT
LATCH
